### Westinghouse Idaho Nuclear Company, Inc.

PCB/Radioactive Contamination Cleanup in CPP-718

PCB-CONTAMINATED SOIL FROM LEAKING TRANSFORMER XFR-872-2

### FINAL REPORT FOR 613 CLEANUP

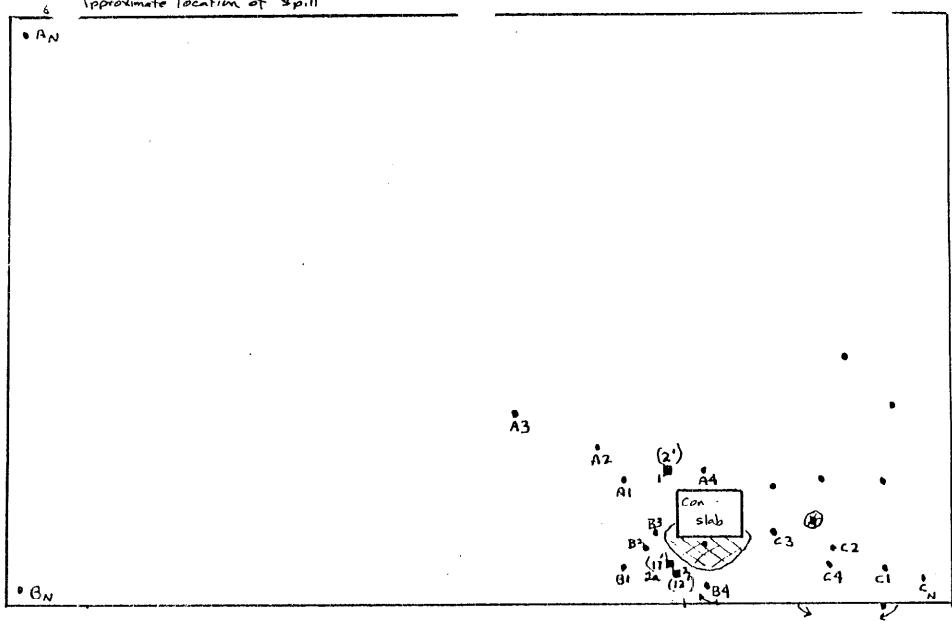
Figure 3. -- Approximate locations of samples laken in and near UREP Substition II.

Using the power auger, one hole was drilled to a depth of 2 ft (Figure 3) and sampled every foot. A second hole was drilled about 2-3 ft from the spill, and samples were taken every 1 1/2 ft (Figure 3). Evidence of oil was observed down to about 12 ft, where drilling was stopped. To ensure that the sampling procedure was not mixing oil-contaminated soil with uncontaminated material at greater depths, a second hole, located approximately 2 ft from the 12-ft hole at about the same distance from the spill (Figure 3), was drilled down to about 10 1/2 ft, where a sample was taken. The next sample taken was at 15 ft. Visual examination and smell indicated that both of these samples also contained oil. Drilling of the hole was terminated when a cobble layer was encountered at 17 ft, causing the successive shearing of two bolts in the auger.

Since the vertical extent of the oil contaminant could not be determined with the equipment at hand, an attempt was made to delineate its lateral extent. Therefore, a number of samples were taken with a hand auger at various distances and directions from the spill (Figure 3). In each case, the surface of the soil beneath the overlying gravel was sampled and examined for oil. If little or no oil was detectable, the hand auger was used to drill a hole down to the uppermost oil-containing layer. In all cases examined, oil was detected within the top 8 in. of soil.

Three 6-8-in.-deep holes were also augered and sampled just outside the fence (Figure 3). Only one of these samples (the one just inside the gate) produced evidence of oil; only a slight oily odor was detected in the others. However, it is likely that higher concentrations of oil are present at lower elevations.

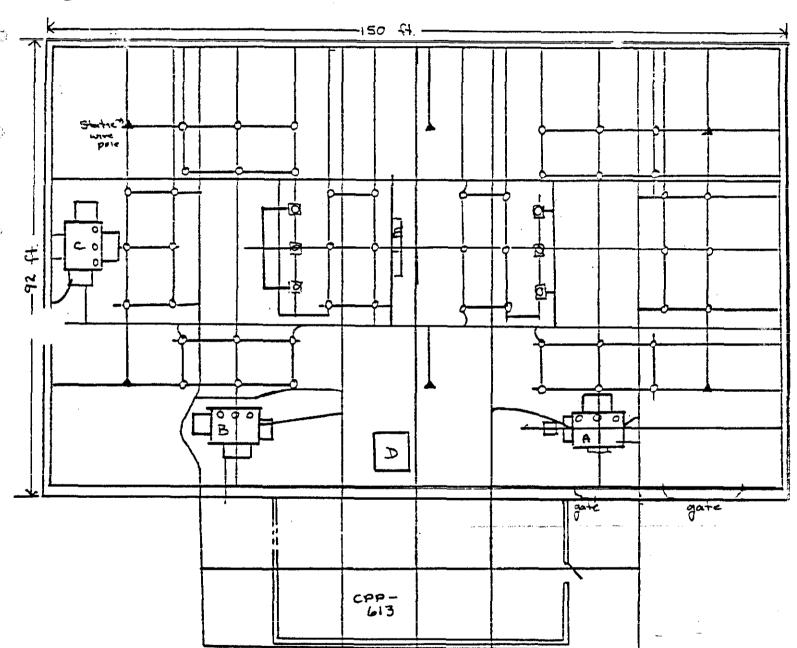
Figure 2 . -- Grounding Grid at CPP-613, UREP Substation II.

In order to try to delineate the extent of the spill, a small 7.5-hp auger was brought in along with hand augers. In designing the sampling plan, care was taken to avoid the radioactive spots since the laboratory certified to analyze PCBs cannot accept mixed waste. Care was also taken to avoid the grounding grid located 18-24 in. below the surface (Figure 2).

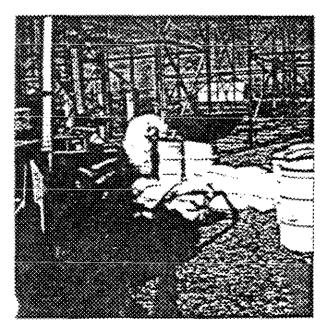
7-19-85 Filling The Bruns with per & Dint

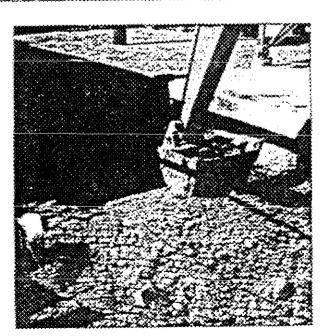
7-19-85 PCB SPILL Clean up

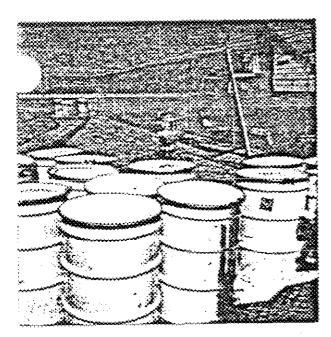
7-19-85 Pell in 17-e Drums FUR Shippment

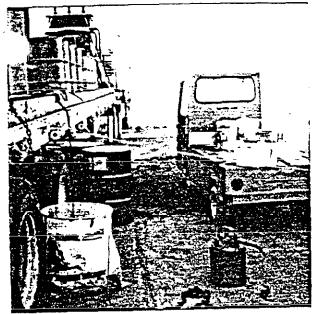
PCB Liquid - 21/1 while Transfering - 01/18 Drems

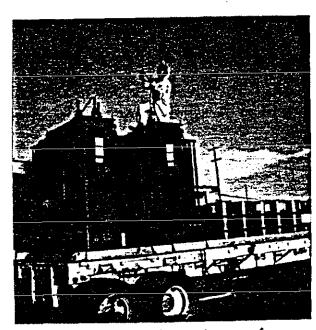
Transfering 28 011 To 55 get Divers.
